Rapid Airfield Damage Recovery Program

Evaluation of Expedient Surfaces for Remote Piloted Aircraft

December 2017

Final report

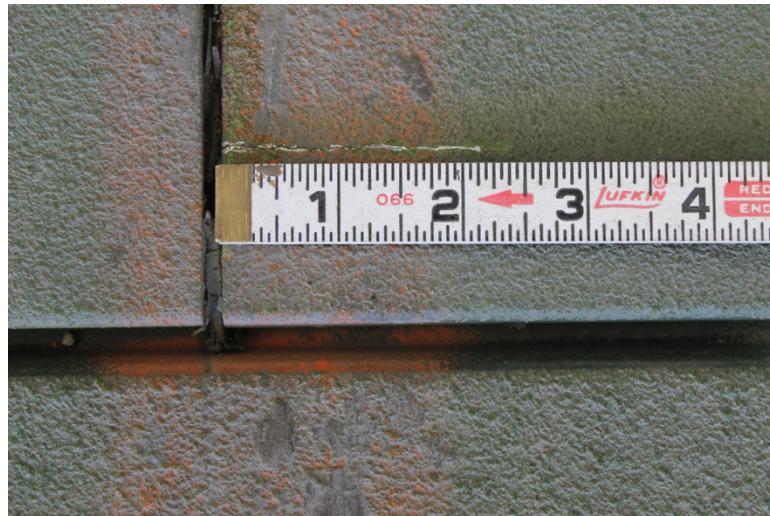
The first damage was noted at 528 passes on the PSA-FT mat system. Several longitudinal joints at the centerline appeared to be faulting and pumping material from the subgrade. The material from the subgrade was pumping through the unsupported longitudinal joint, and the west side of the affected joint was more elevated than the east side. Throughout the remainder of the test, the test tire was increasingly unstable and bounced when it traveled along the centerline. After 1,000 passes, deformation of the surface of 7 panels with joints along the centerline was noted. Center panels, however, appeared to bow upward, or “crown,” at the centerline. After 1,936 passes, cracking developed on the surface of 9 panels with their joints at the centerline. Most cracks were 1-2 in. long, propagated perpendicular to the direction of traffic, and were located approximately 1 in. from the north or south edge of the panel (Figure 4.1). Cracking continued to propagate and developed in a total of 24 panels after 3,280 passes. However, they were still under 4.5 in. in length and did not pose a hazard to the load cart tire.

Figure 4.1. Cracking on surface of PSA-FT after 1,936 passes.

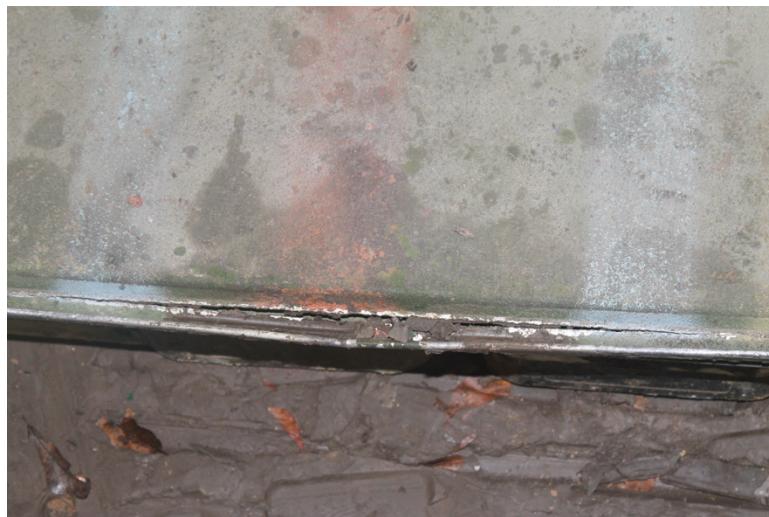
Some cracking was noted on a few panels after they were removed from the test-section subgrade. Most of cracks were observed at the corner of the end connector, where the weld bead was located. Photographs of these are shown in Figure 4.4. One panel had a 19-in.-long tear along the male connector (Figure 4.5). Panels were somewhat difficult to remove from the subgrade for inspection because subgrade material was lodged into the locking bar slot, making it hard to slide out the locking bar to separate panels. However, the general condition of the PSA-FT-R test item was good and it was concluded that the test item did not fail by mat breakage after 7,398 passes.

Figure 4.4. Crack along male hinge of PSA-FT-R panel.

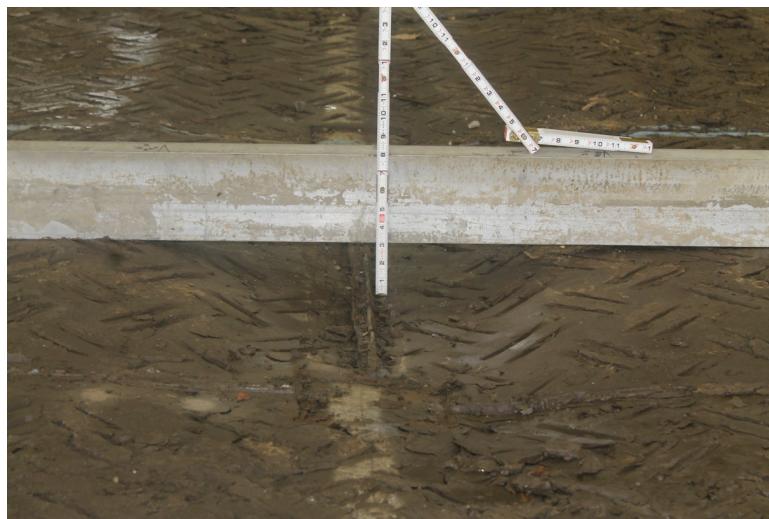
Figure 4.6. Posttest subgrade of DuraDeck mat system.
